Memorial Pool Complex – Main Building

Detailed Seismic Assessment Report

Date: 30 May 2018
Reference: 2-9B341.00
Status: Issue 2

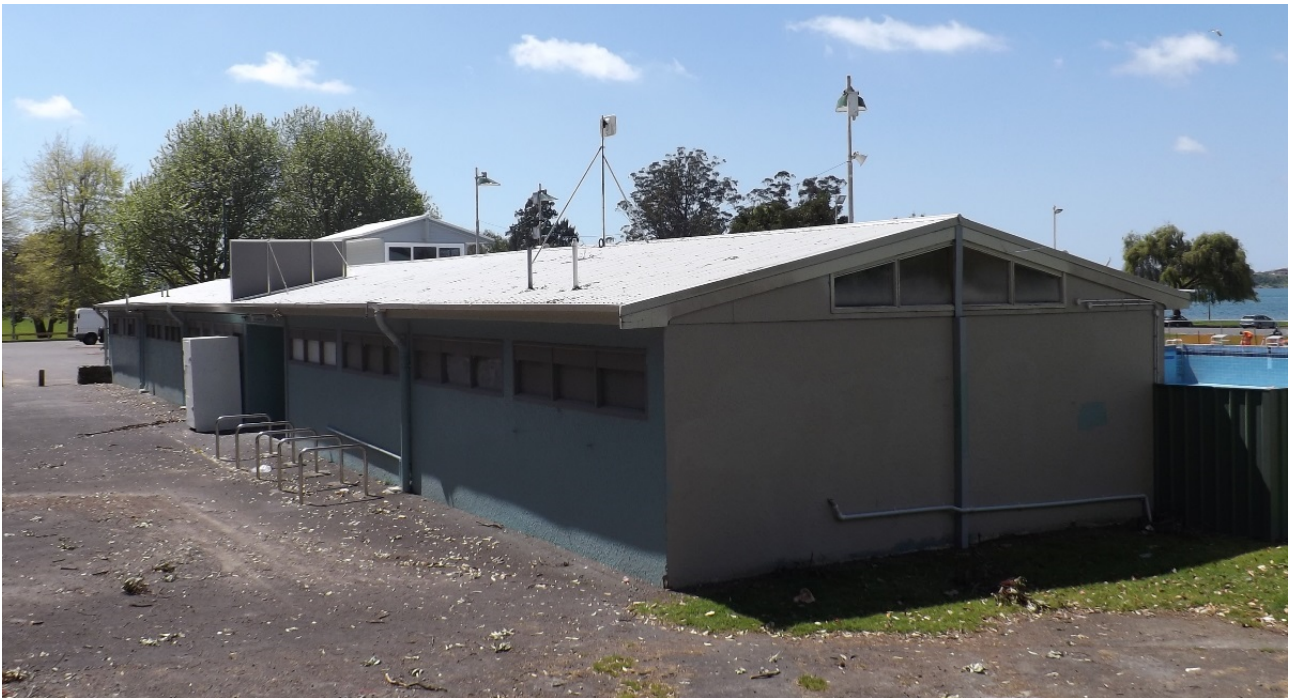
Figure 4: Southern and Western elevation of the building

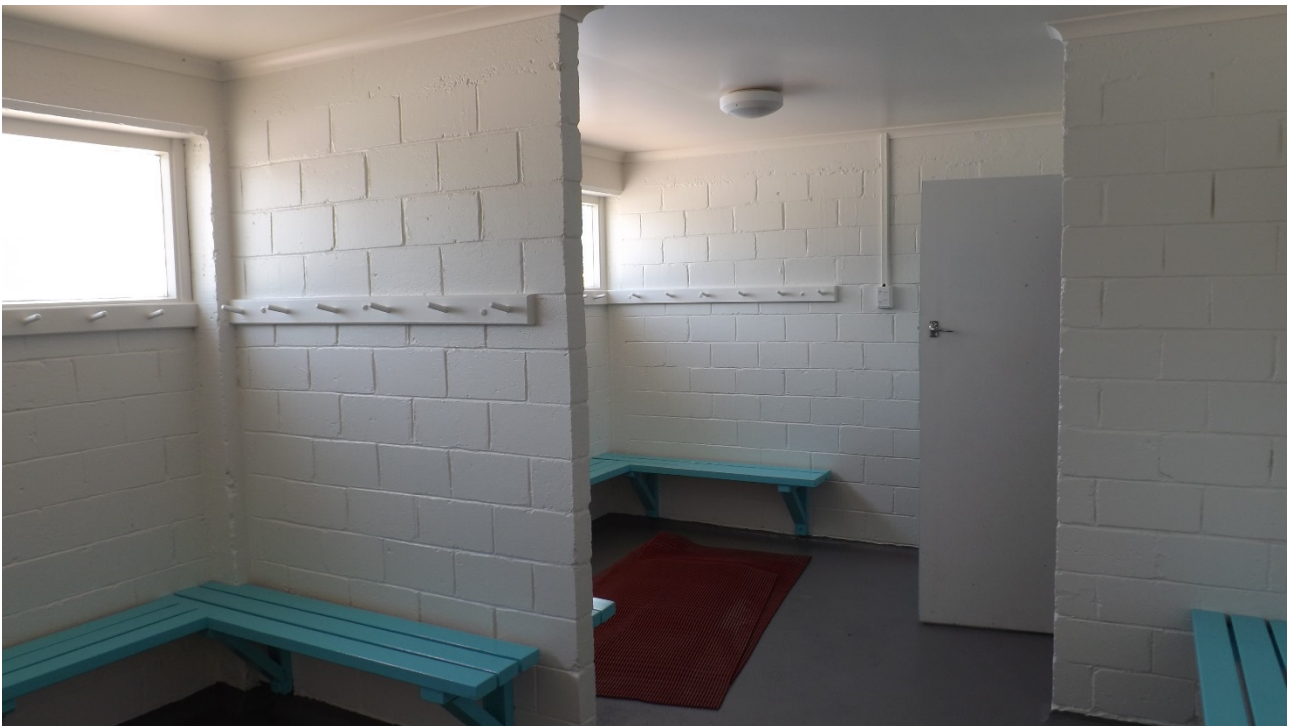
Figure 3: Internal view of building interior with internal masonry walls

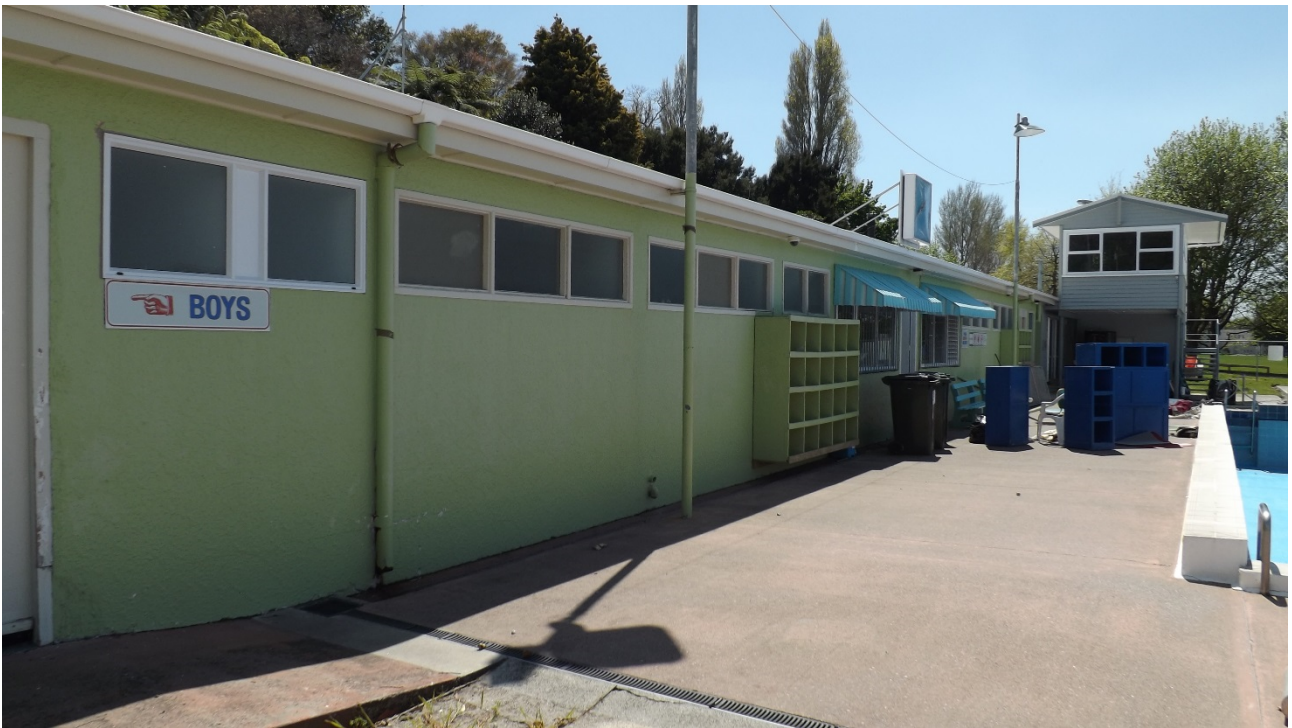
Figure 6: Eastern Elevation

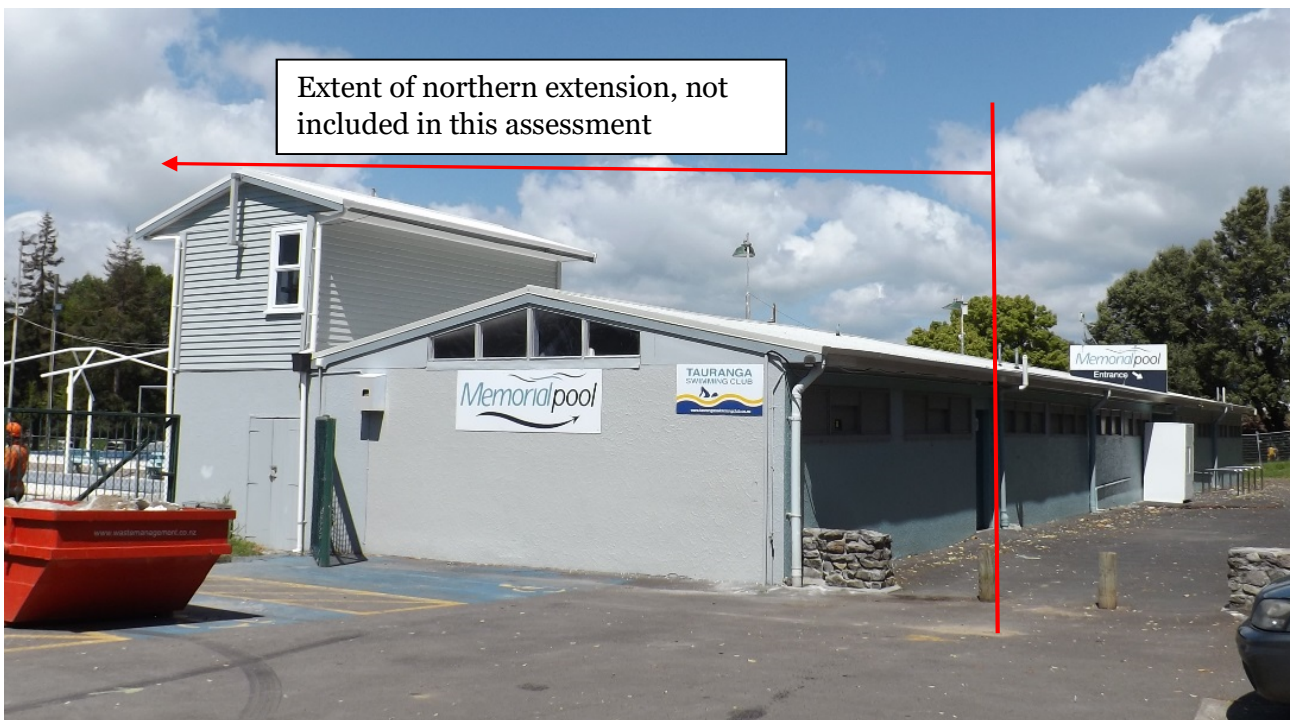
Figure 5: Transverse end wall (Northern Elevation). The extension to the left is not included in this assessment
