Memorial Pool Complex – Main Building

Detailed Seismic Assessment Report

Date: 30 May 2018
Reference: 2-9B341.00
Status: Issue 2

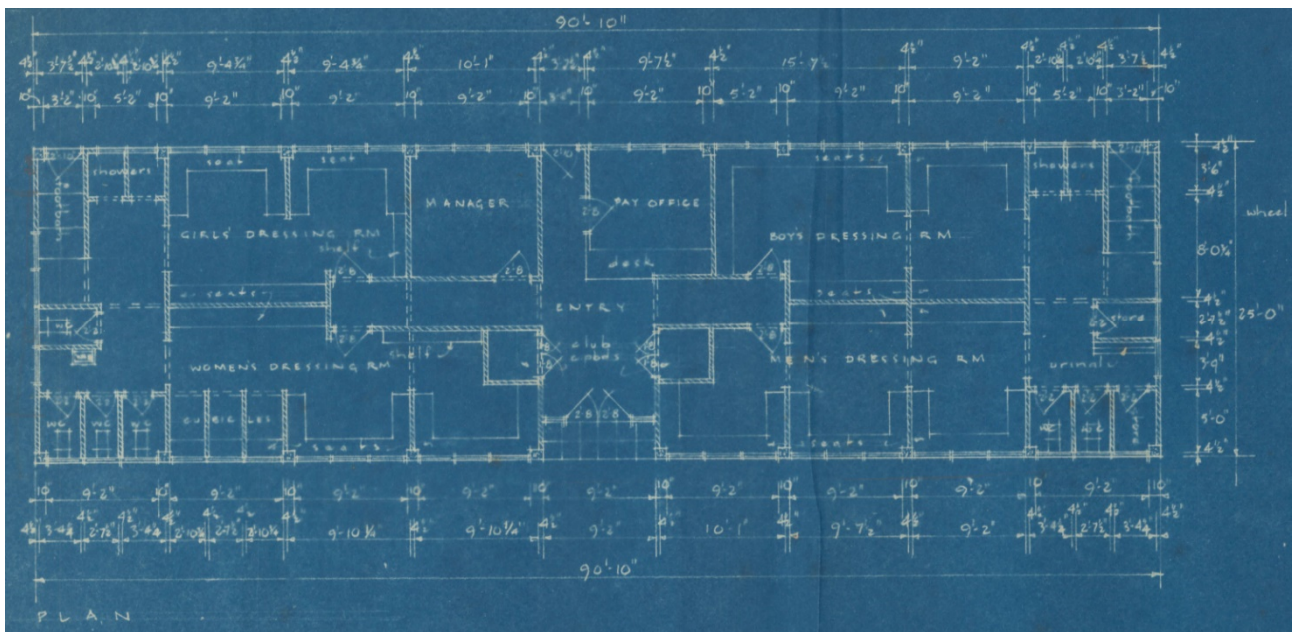
Figure 2: Overall plan of the Memorial Pool building

The original building is a 27.7m long x 7.62m wide with a maximum ceiling height of approximately 2.8m. The structural drawings show that the ground floor of the building is supported on strip foundations around the perimeter of the building. Figure 2 below illustrates the original plan layout of the building, excluding the northern extension.
