MEMORIAL POOL SLAB ON GRADE OBSERVATIONS - 9-12-2024

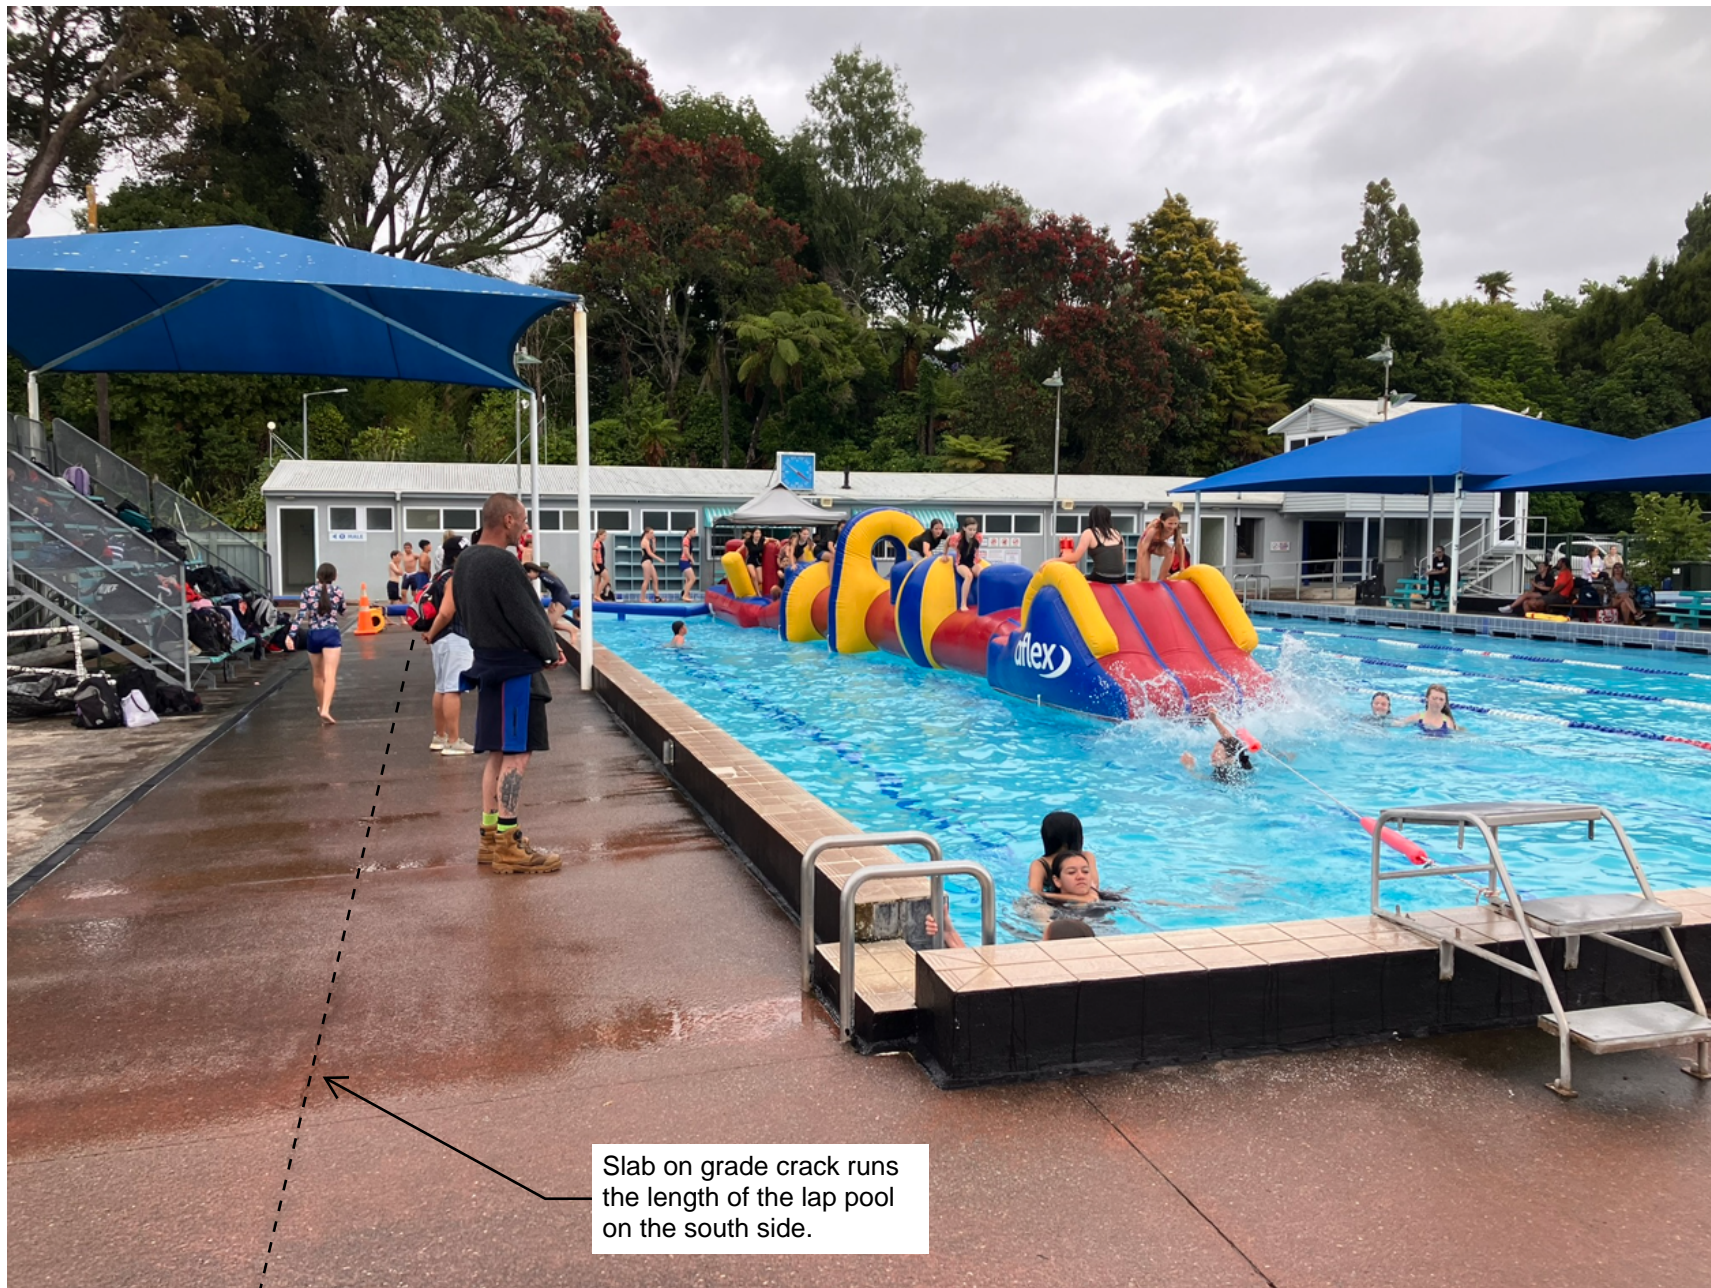
Slab on grade crack runs the length of the lap pool on the south side.

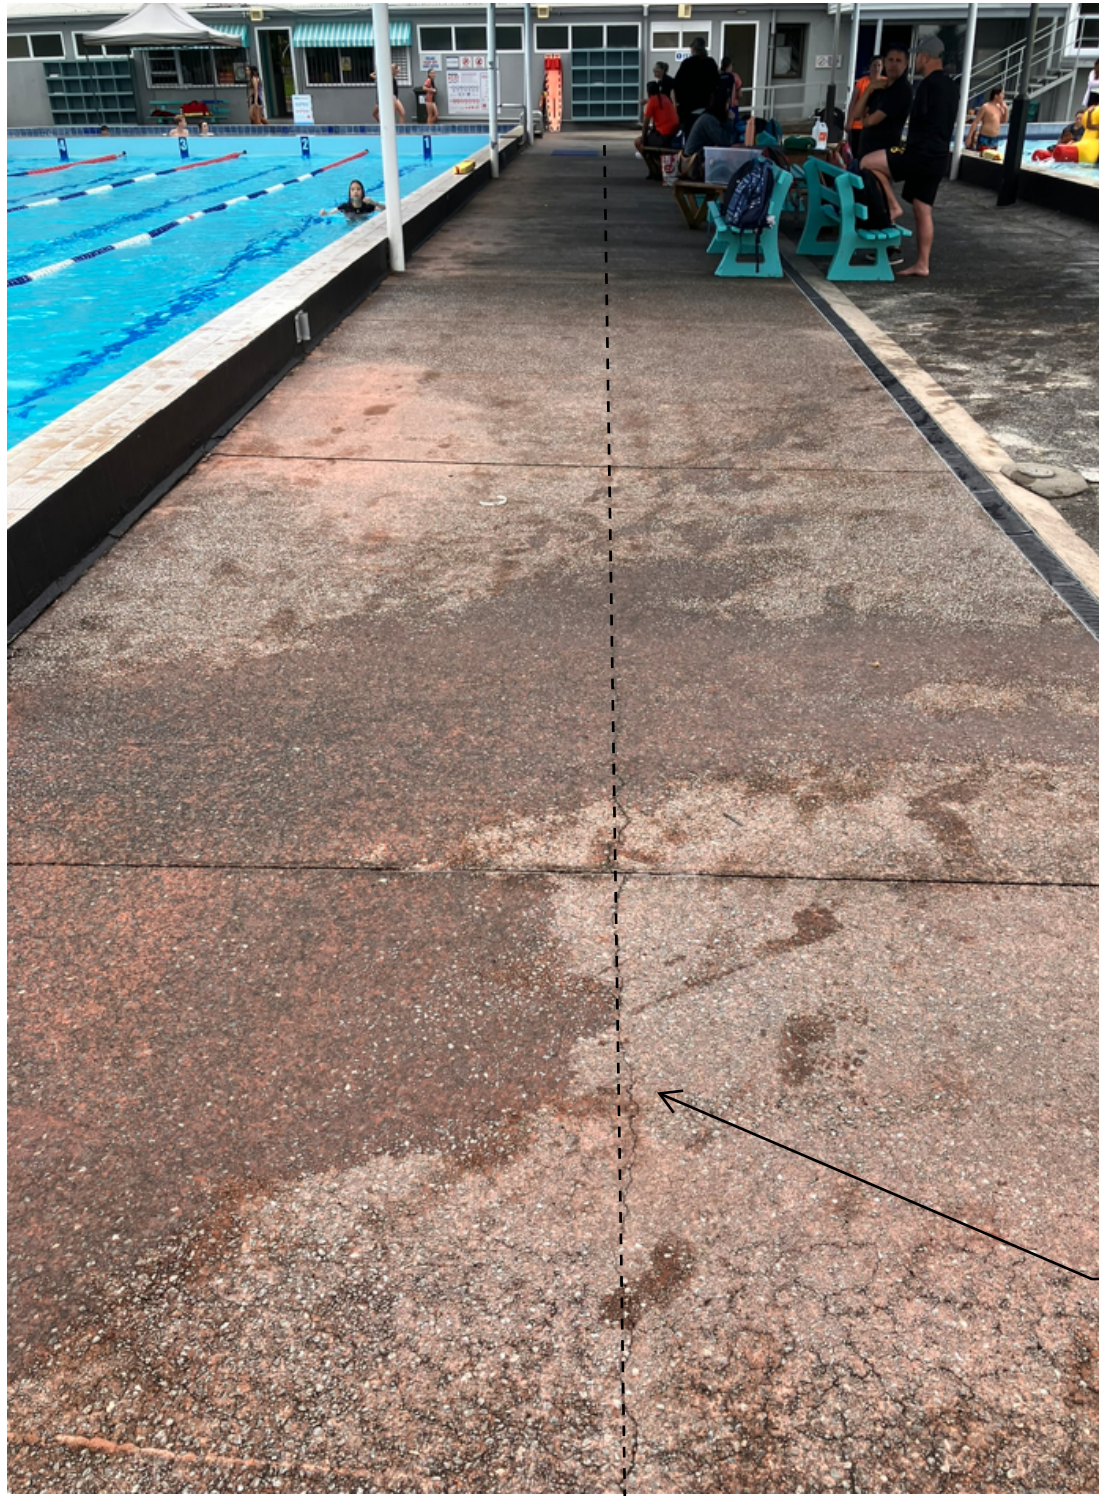
Slab on grade crack runs the length of the lap pool on the north side.

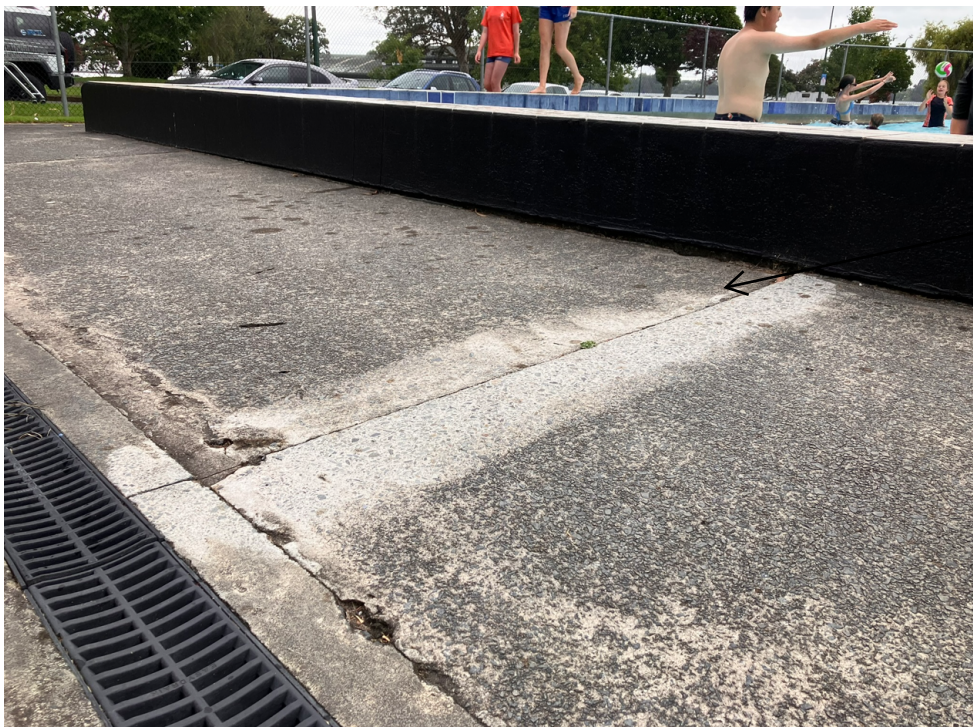
Slab on grade subsidized on the west side of the leisure pool. Top of concrete was ground flush to avoid tripping hazards.

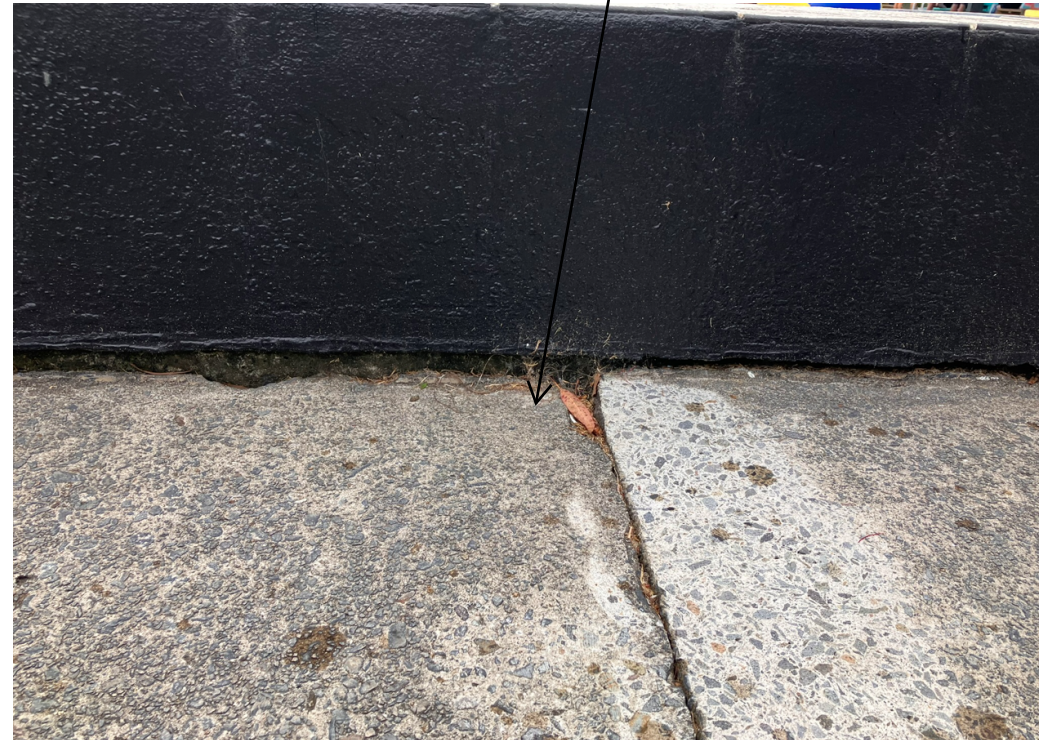
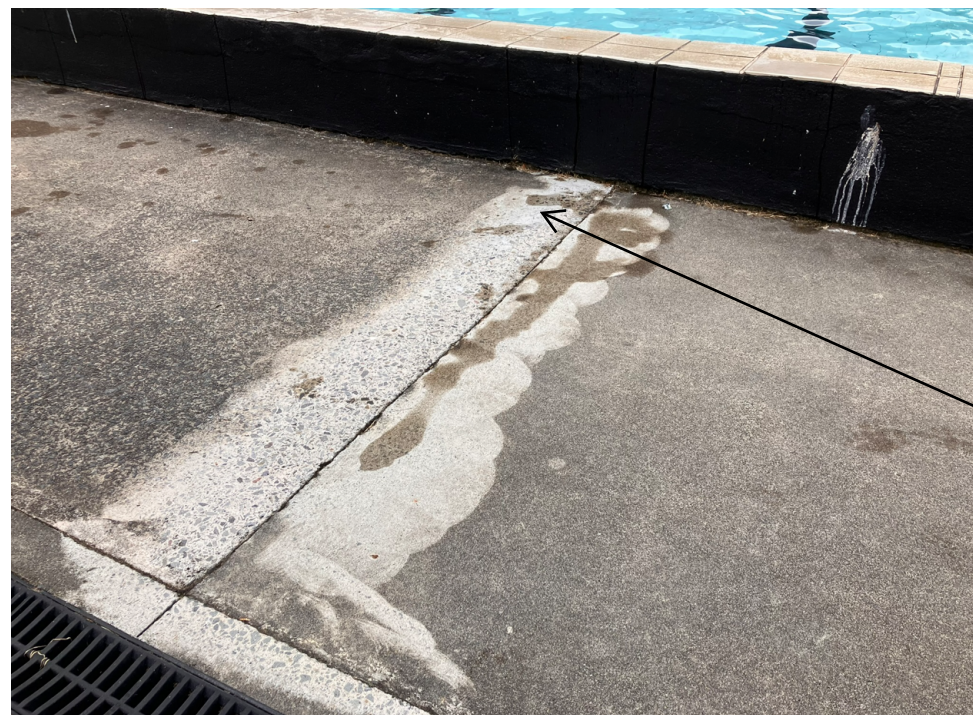
Slab on grade subsidized on the east side of the leisure pool. Top of concrete was ground flush to avoid tripping hazards.
